**LOWER WOODS  
POND DAM**

PHASE I INSPECTION REPORT  
NATIONAL DAM INSPECTION PROGRAM

6 National Dam Inspection Report. Lower Woods Pond Dam (PA-00152, DER I.D. 64-11), Delaware River Basin, E. Branch Dyberry Creek, Wayne County, Pennsylvania. Phase I Inspection Report.

LOWER WOODS POND DAM  
WAYNE COUNTY, PENNSYLVANIA

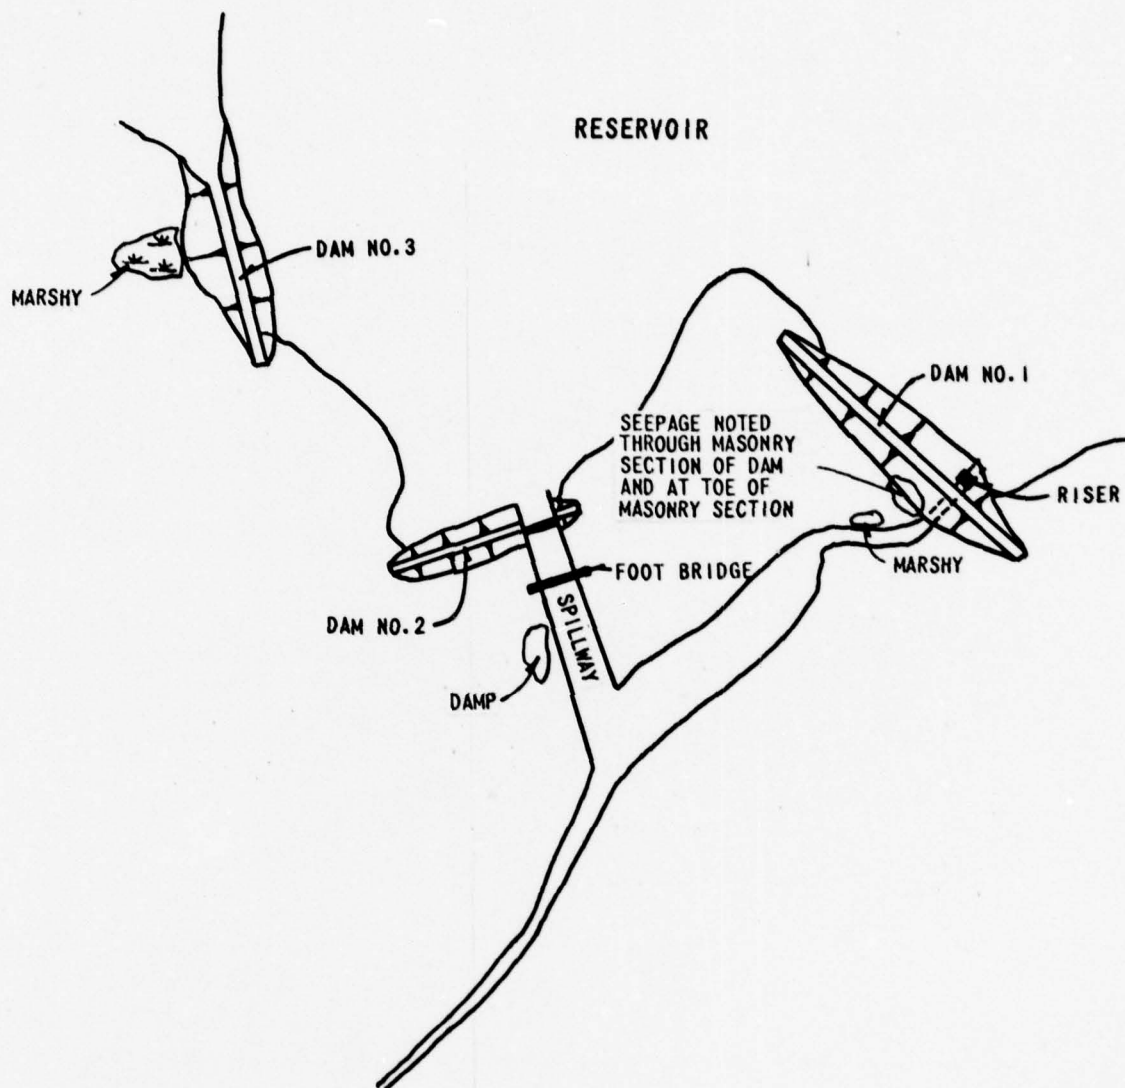
SHEET 5a OF 11

Clear seepage was noted beyond the toe of all three embankments, particularly of embankment No. 3, where the entire area beyond the downstream toe was marshy. At Dam No. 1, considerable seepage was noted beyond the toe between the natural hillside of the right abutment and the discharge channel. There was minor seepage adjacent to the discharge channel approximately 175 feet downstream of the No. 2 dam.

VISUAL EXAMINATION OF	OBSERVATIONS	REMARKS OR RECOMMENDATIONS
ANY NOTICEABLE SEEPAGE	Yes. See sheet 5a. Some slight seepage was noted at the base of the masonry portion of the main dam. The quantity could not be determined due to dense growth.	
STRUCTURE TO ABUTMENT/EMBANKMENT JUNCTIONS	No unusual distortions were observed. The crest was relatively level.	
DRAINS	N/A	
WATER PASSAGES	N/A	
FOUNDATION	Could not be inspected.

2. Should the results of seepage evaluation and monitoring warrant, a detailed study of the condition should be made and necessary remedial measures taken. If seepage exiting from the toe or masonry section of Dam No. 1 increases, the possibility of piping of the upstream earth section should be studied in detail and appropriate remedial measures taken.

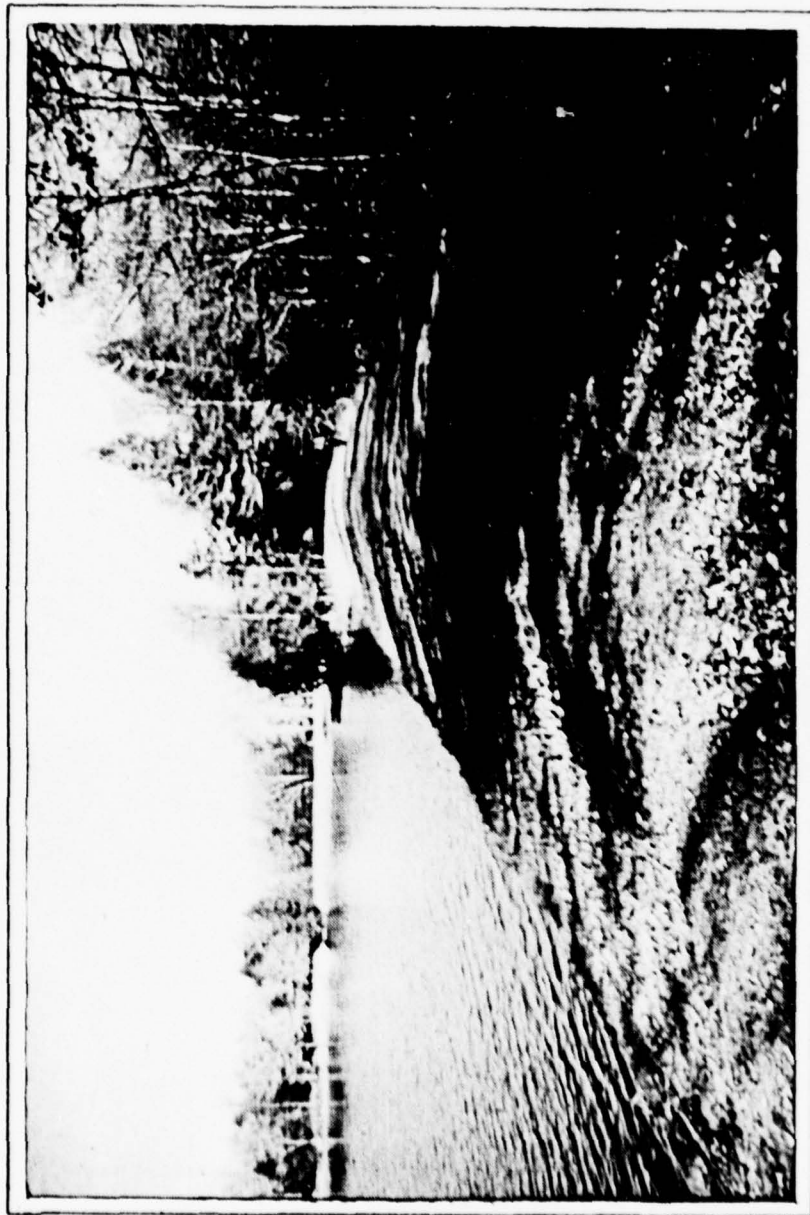
PHOTOGRAPH NO. 1

OVERVIEW OF UPSTREAM SLOPE OF  
EMBANKMENT NO. 3. EMBANKMENT  
NO. 2 IS IN BACKGROUND

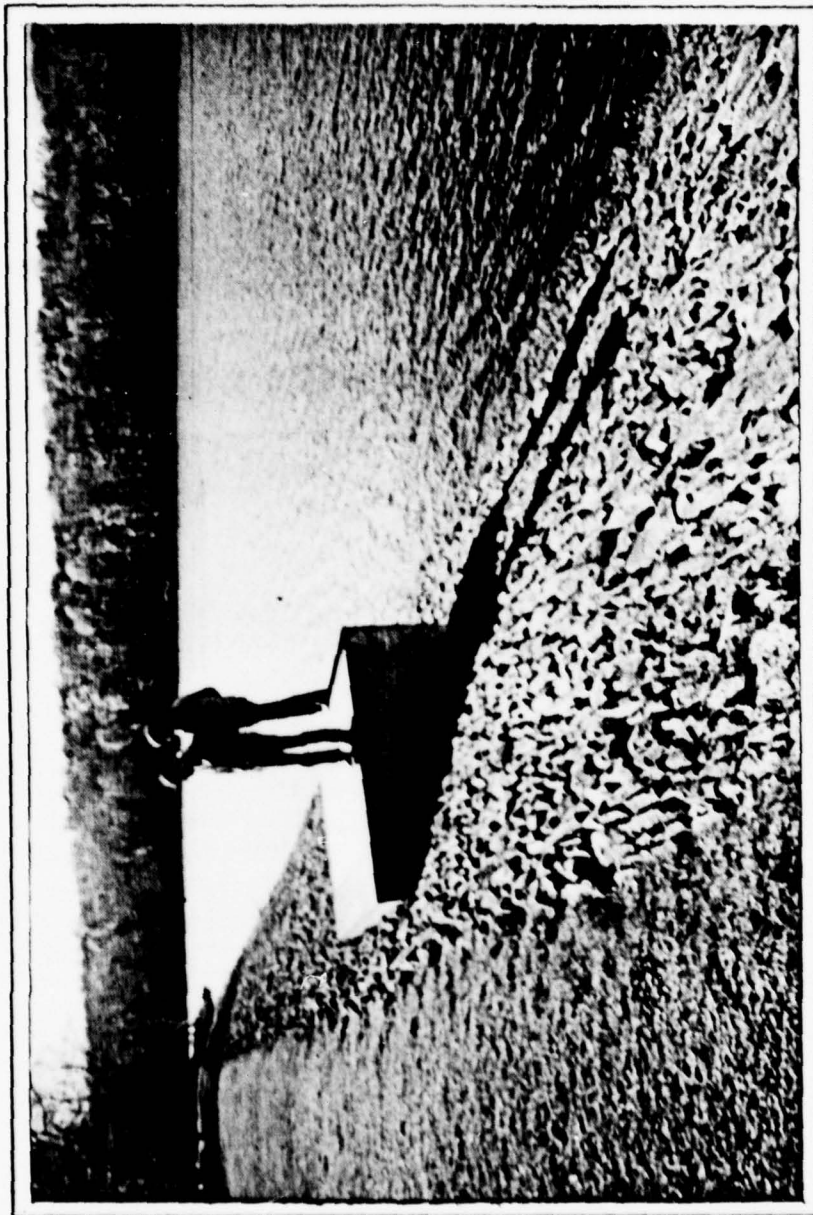
PHOTOGRAPH NO. 2

1. Intake Conduit. The exposed sections of the principal spillway were inspected, which included the top of the tower and the conduit outlet (Photos 2 and 3). The inside of the riser could not be inspected as the access hatch was locked. No significant concrete cracking, spalling, or signs of deterioration were noted.

OVERVIEW OF UPSTREAM SLOPE OF EMBANKMENT  
NO. 1 AND INTAKE RISER.

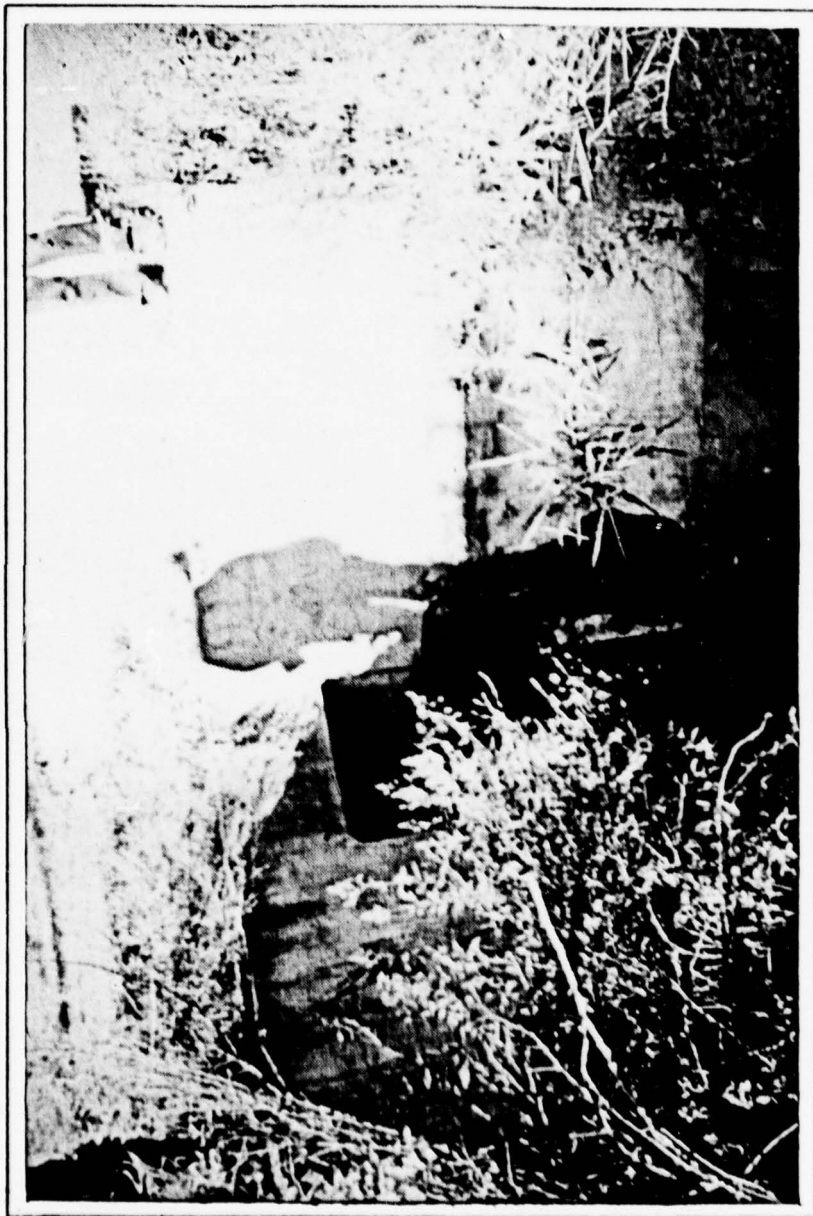
PHOTOGRAPH NO. 3

DISCHARGE CULVERT AT DOWNSTREAM TOE  
OF EMBANKMENT NO. 1.

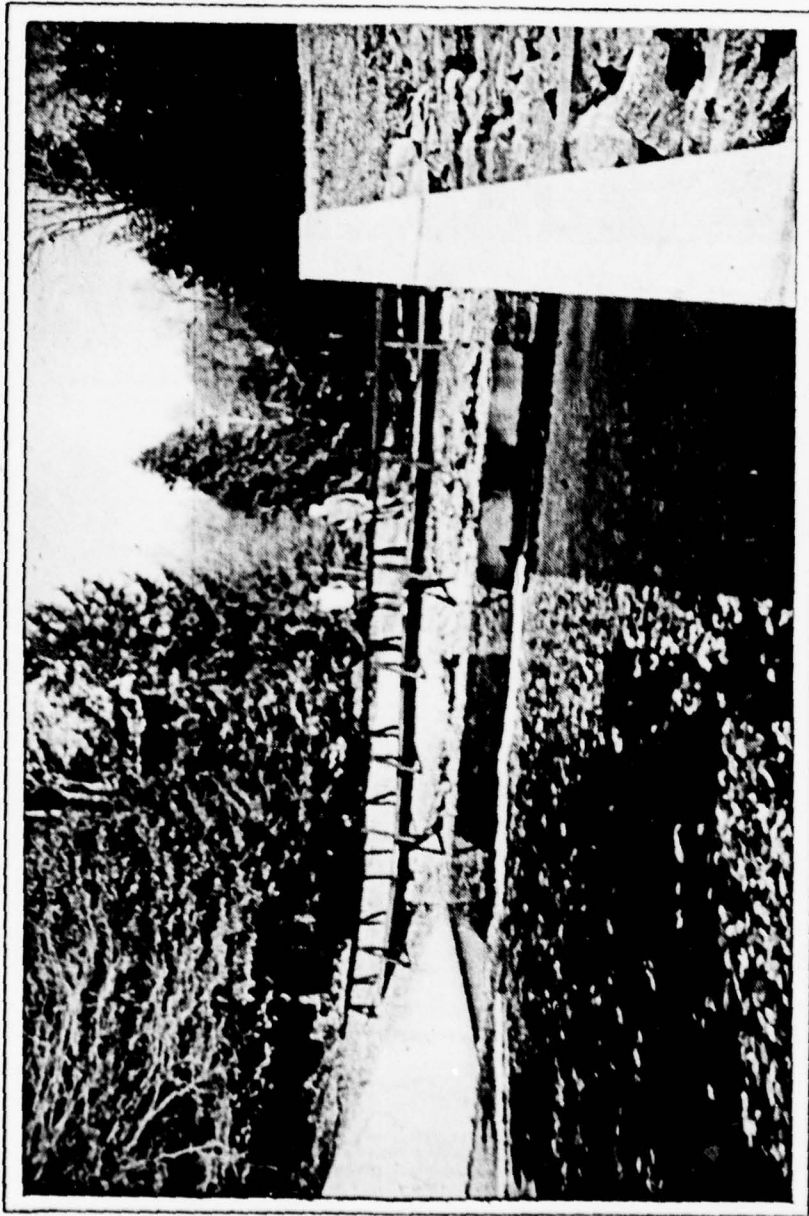
There was 0.4 feet of settlement noted at the right side of the spillway wall in Dam No. 2. However, the concrete anti-seep fin was at the design elevation, and this slight

The spillway approach and discharge channels were inspected and found to be in good condition. However, the foot bridge located immediately downstream, as shown in Photograph 4, is on rock piers and, in the event of a severe storm, is expected to be washed out. The spillway discharge capacity is not expected to be affected by failure of this bridge.

EMERGENCY SPILLWAY. NOTE FOOT BRIDGE  
DOWNSTREAM AND EMBANKMENT SETTLEMENT  
ADJACENT TO RIGHT SPILLWAY WALL.

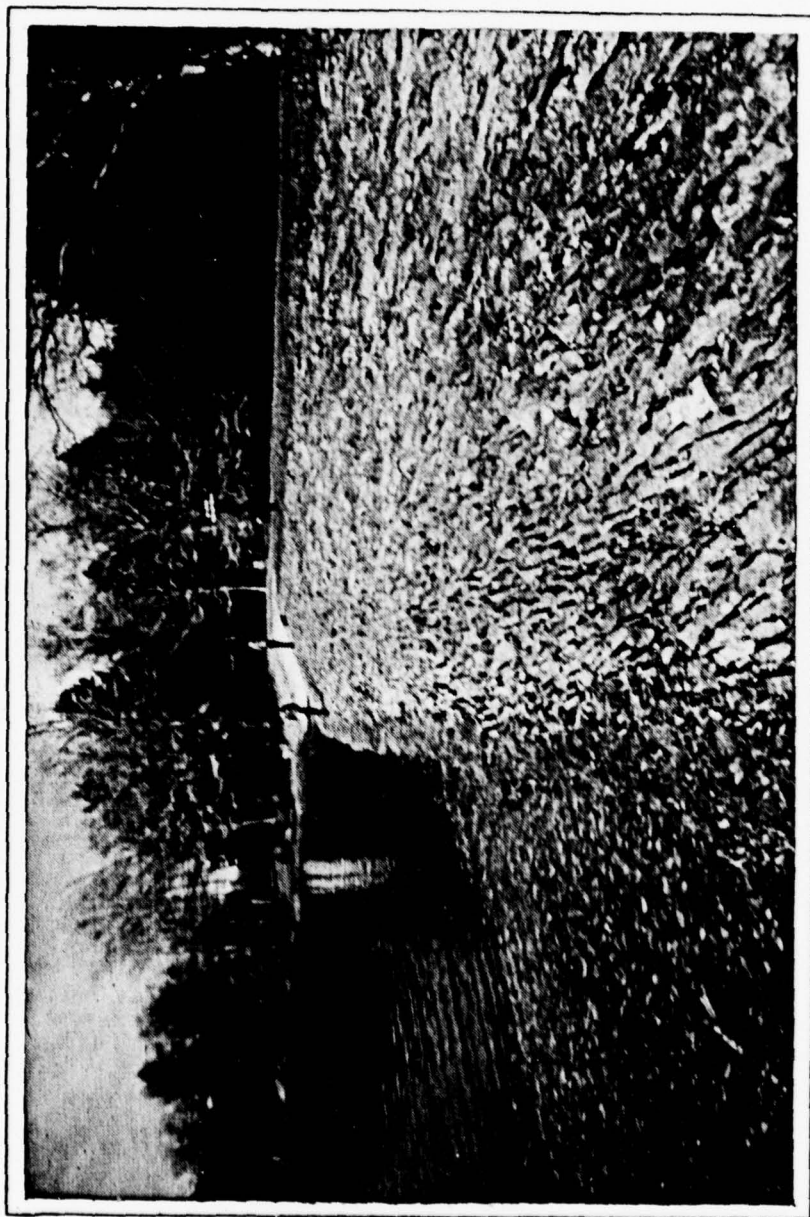
The hand-placed riprap on the upstream slopes of all three embankments was found to be in good condition. The quality of the rock was assessed to be excellent. The downstream slopes on all three dams are in good condition, grass covered and, evidently, well maintained. The masonry portion of Dam No. 1 was assessed to be in good condition. The downstream slope showed little or no sign of distortion. There is undesirable woody vegetation growing between the masonry blocks and on the slopes. The woody vegetation is undesirable and should be removed.

UPSTREAM SLOPE COVERED WITH HAND  
PLACED RIPRAP. EMBANKMENT NO. 2.

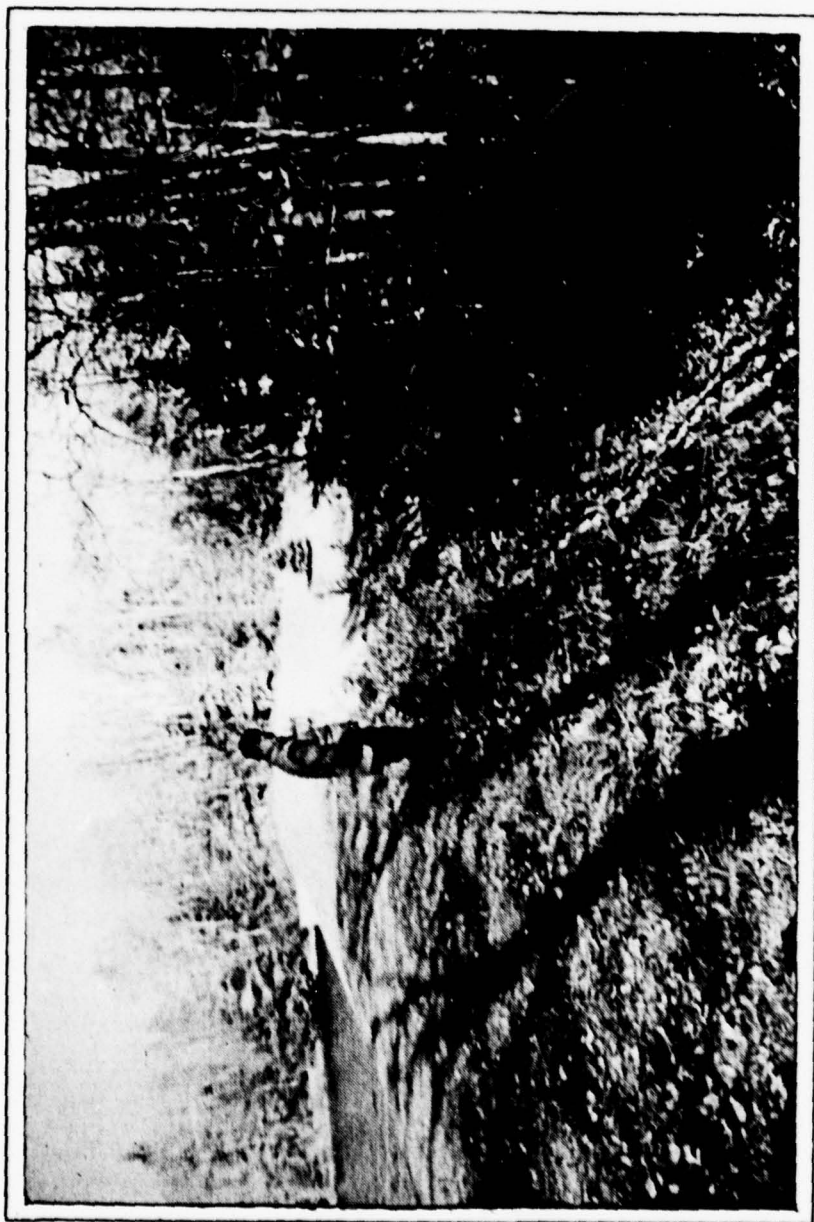
PHOTOGRAPH NO. 7

DOWNSTREAM SLOPE OF EMBANKMENT NO. 1.

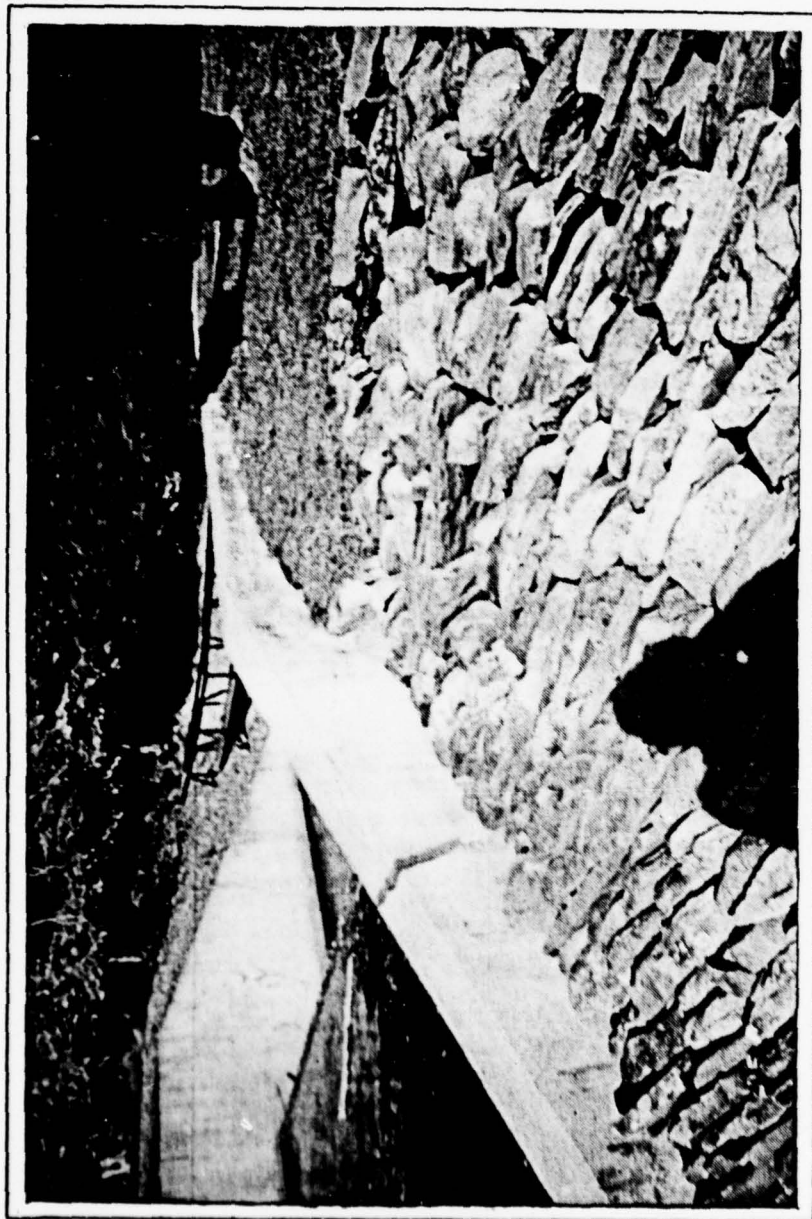
PHOTOGRAPH NO. 9

UPSTREAM SLOPE OF EMBANKMENT NO. 2.  
NOTE RIPRAP AND EMBANKMENT SETTLEMENT.

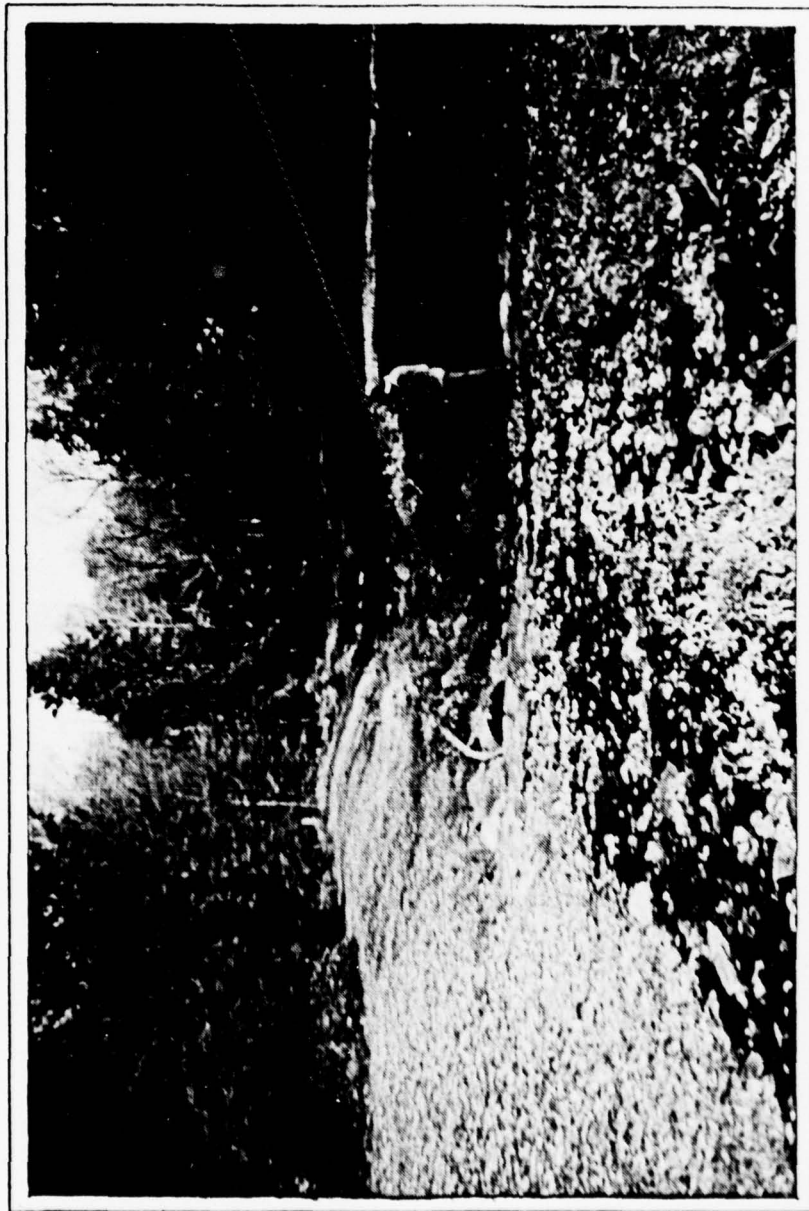
e. Downstream Channel. Immediately downstream, both the principal spillway and emergency spillway discharge into rocky stream channels which converge approximately 250 feet downstream from the emergency spillway. The channel was inspected and is assessed to be in good condition. At the intersection of Dyberry Creek Road and Route 371, approximately 1 mile below the dam, are several structures including residential dwellings which would be subject to damage.

DOWNSTREAM CHANNEL BELOW EMERGENCY  
SPILLWAY. PHOTO TAKEN FROM FOOT  
BRIDGE.

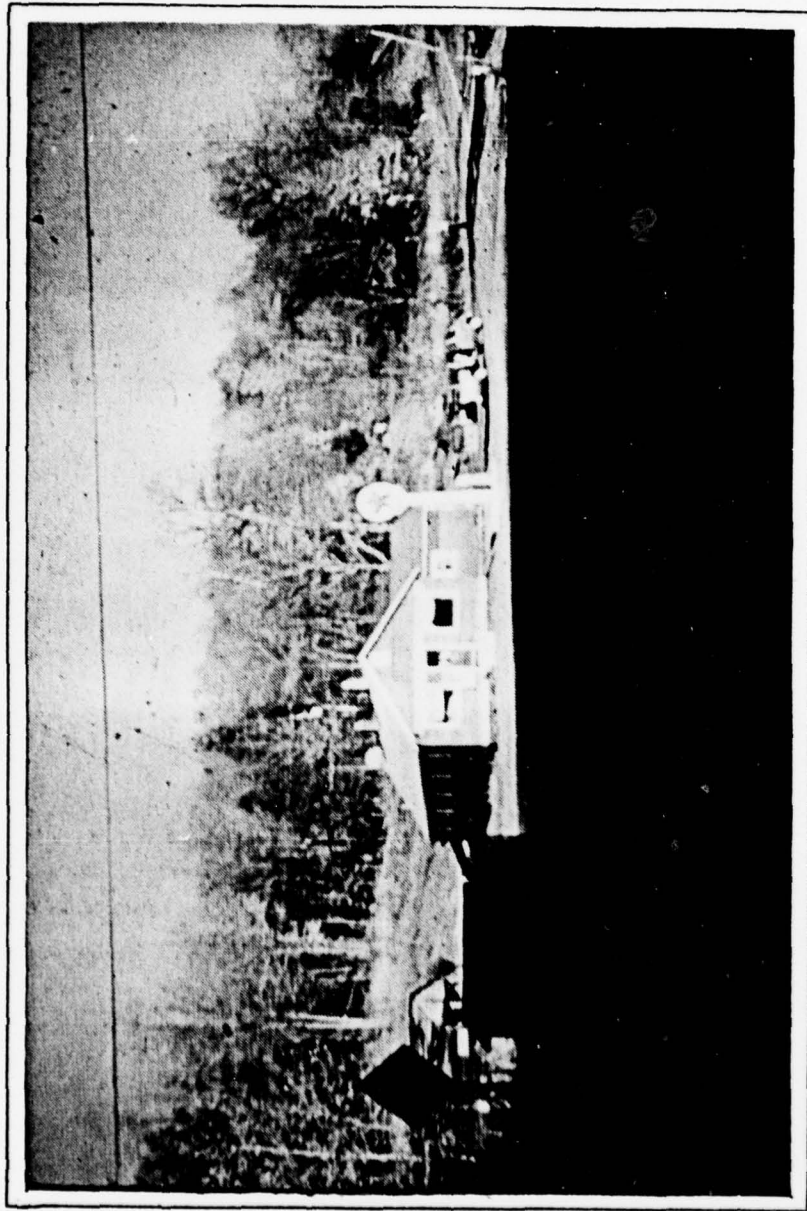
PHOTOGRAPH NO. 11

f. Downstream Conditions. Lower Woods Pond Dam is located about 1 mile above PA Route 371 where there are two homes subject to damage in the event of dam failure. Further downstream along the east branch of Dyberry Creek are homes built adjacent to the creek in the flood plain, which are also subject to damage.

DISCHARGE FLOWS THROUGH POPULATED  
INTERSECTION ABOUT 7/8 MILES BELOW  
THE DAM.

The Pennsylvania Fish Commission has an emergency plan which includes guidelines for observing various conditions of the dam during periods of heavy precipitation. This plan should be expanded to include a procedure in the event of an emergency for warning downstream residents.
